BAIR DAM

MANUAL FOR OPERATION AND MAINTENANCE

**State Water Projects Bureau
Water Resources Division
Department of Natural Resources and Conservation
48 North Last Chance Gulch
P.O. Box 201601
Helena, MT 59620-1601**

**Initial Publication May 1995
Revised July 2001**

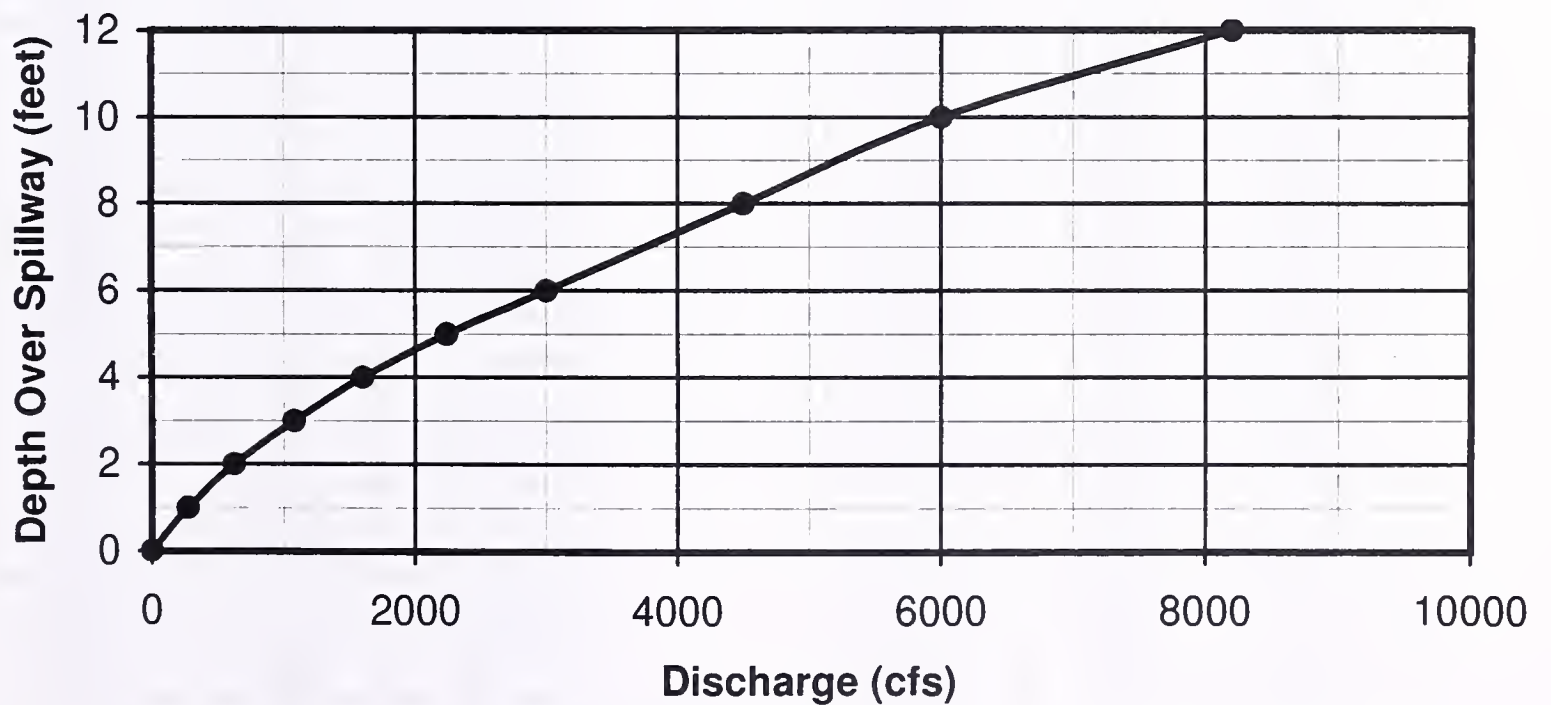
BAIR DAM SPILLWAY RATING CURVE

Depth Over Crest (feet)	Elevation (feet)	Discharge (cfs)
0	5324.6	0
1.0	5325.6	275
2.0	5326.6	625
3.0	5327.6	1080
4.0	5328.6	1600
5.0	5329.6	2240
6.0	5330.6	3000
8.0	5332.6	4500
10.0	5334.6	6000
12.0	5336.6	8200

Note: Data from the Corps of Engineers Phase 1 Inspection Report (1981).

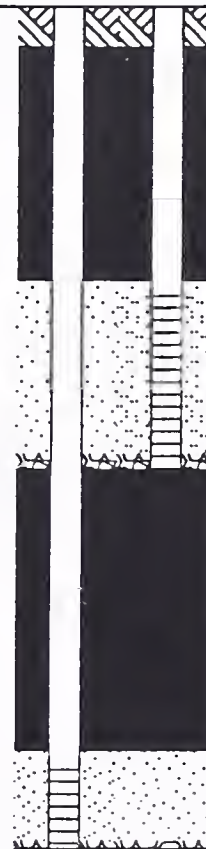
18.0 CSSI 10x20 Silica Sand Filter Pack (18' - 27.8') 5249.4

28.8 Slough (27.8'-28.8') 5238.6
Bentonite Hole Plug (28.8' - 47.5')47.5 CSSI 10x20 Silica Sand Filter Pack (47.5' - 52.5') 5219.9
52.5 5214.91" PVC Pipe
Typical1" PVC Pipe
Typical1" Slotted
(0.020") PVC
(18'-28.8')1" Slotted
(0.020") PVC
(47.5'-52.5')

Five drill holes in the dam embankment and one slope inclinometer in the left abutment above the spillway were installed in 1999 (see Figure 4). Generally, two piezometers were installed in each drill hole. Soil profiles of the drill holes and details as to how the wells were constructed are shown in Appendix D.

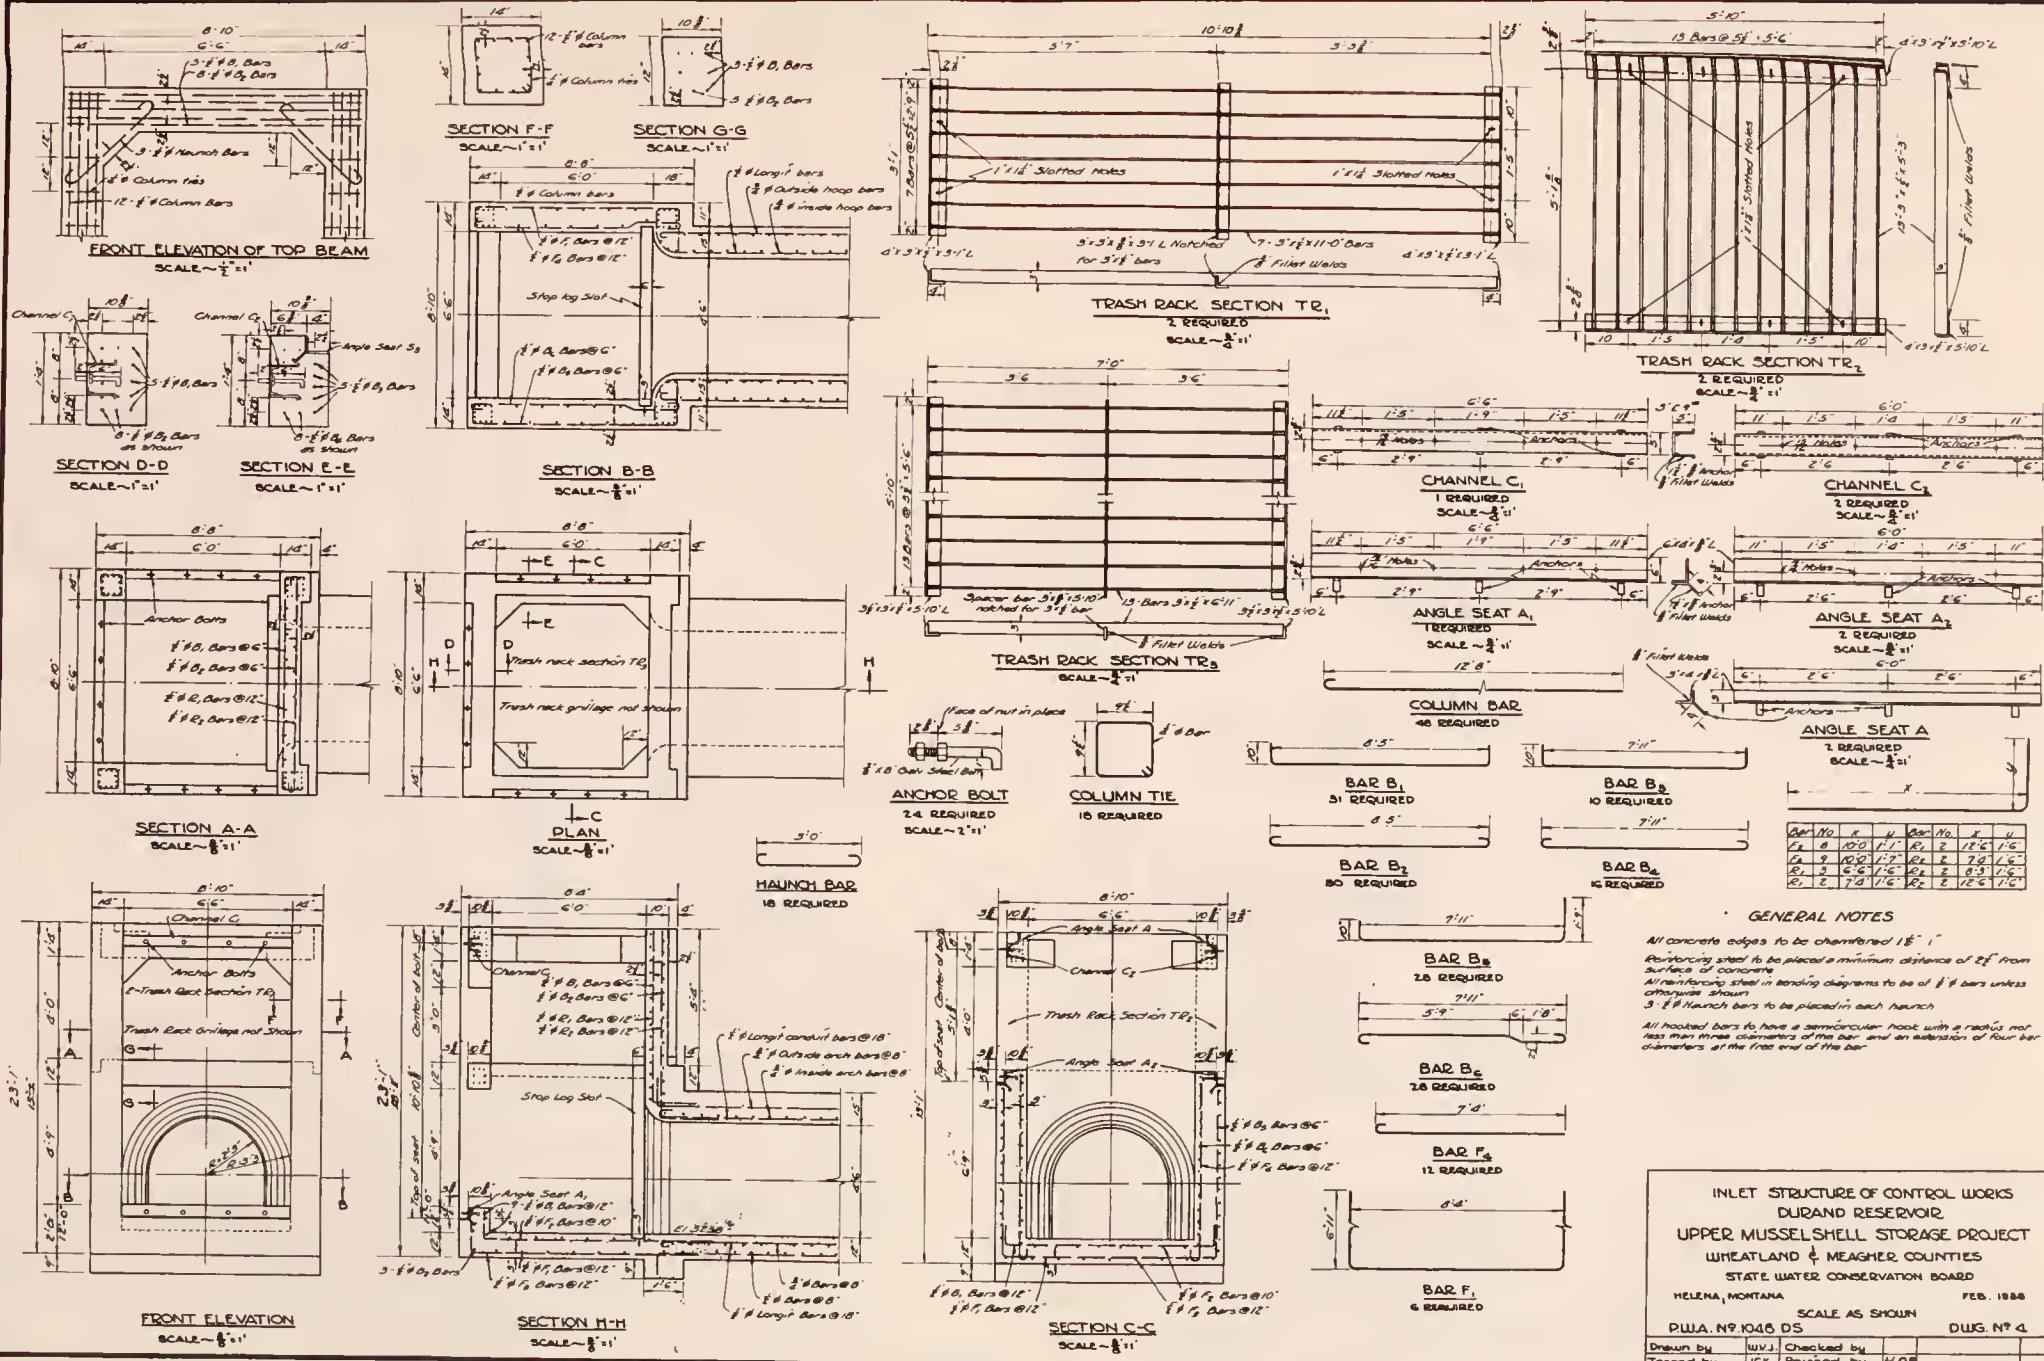
INLET STRUCTURE OF CONTROL WORKS
DURAND RESERVOIR
UPPER MUSSEL SHELL STORAGE PROJECT
WHEATLAND & MEAGHER COUNTIES
STATE WATER CONSERVATION BOARD
HELENA, MONTANA
FEB. 1988
SCALE AS SHOWN
PWLA N9.1046 DS
DWG. N9.4
Drawn by WVS Checked by JCK
Traced by JCK Revised by HOB
